GEOTECHNICAL STUDY

Report No. 2203-09-B-2

Subject: Due Diligence Geotechnical Study, Proposed Capalina Apartments, APN 466120002, Capalina Road east of North Rancho Santa Fe, San Marcos, California

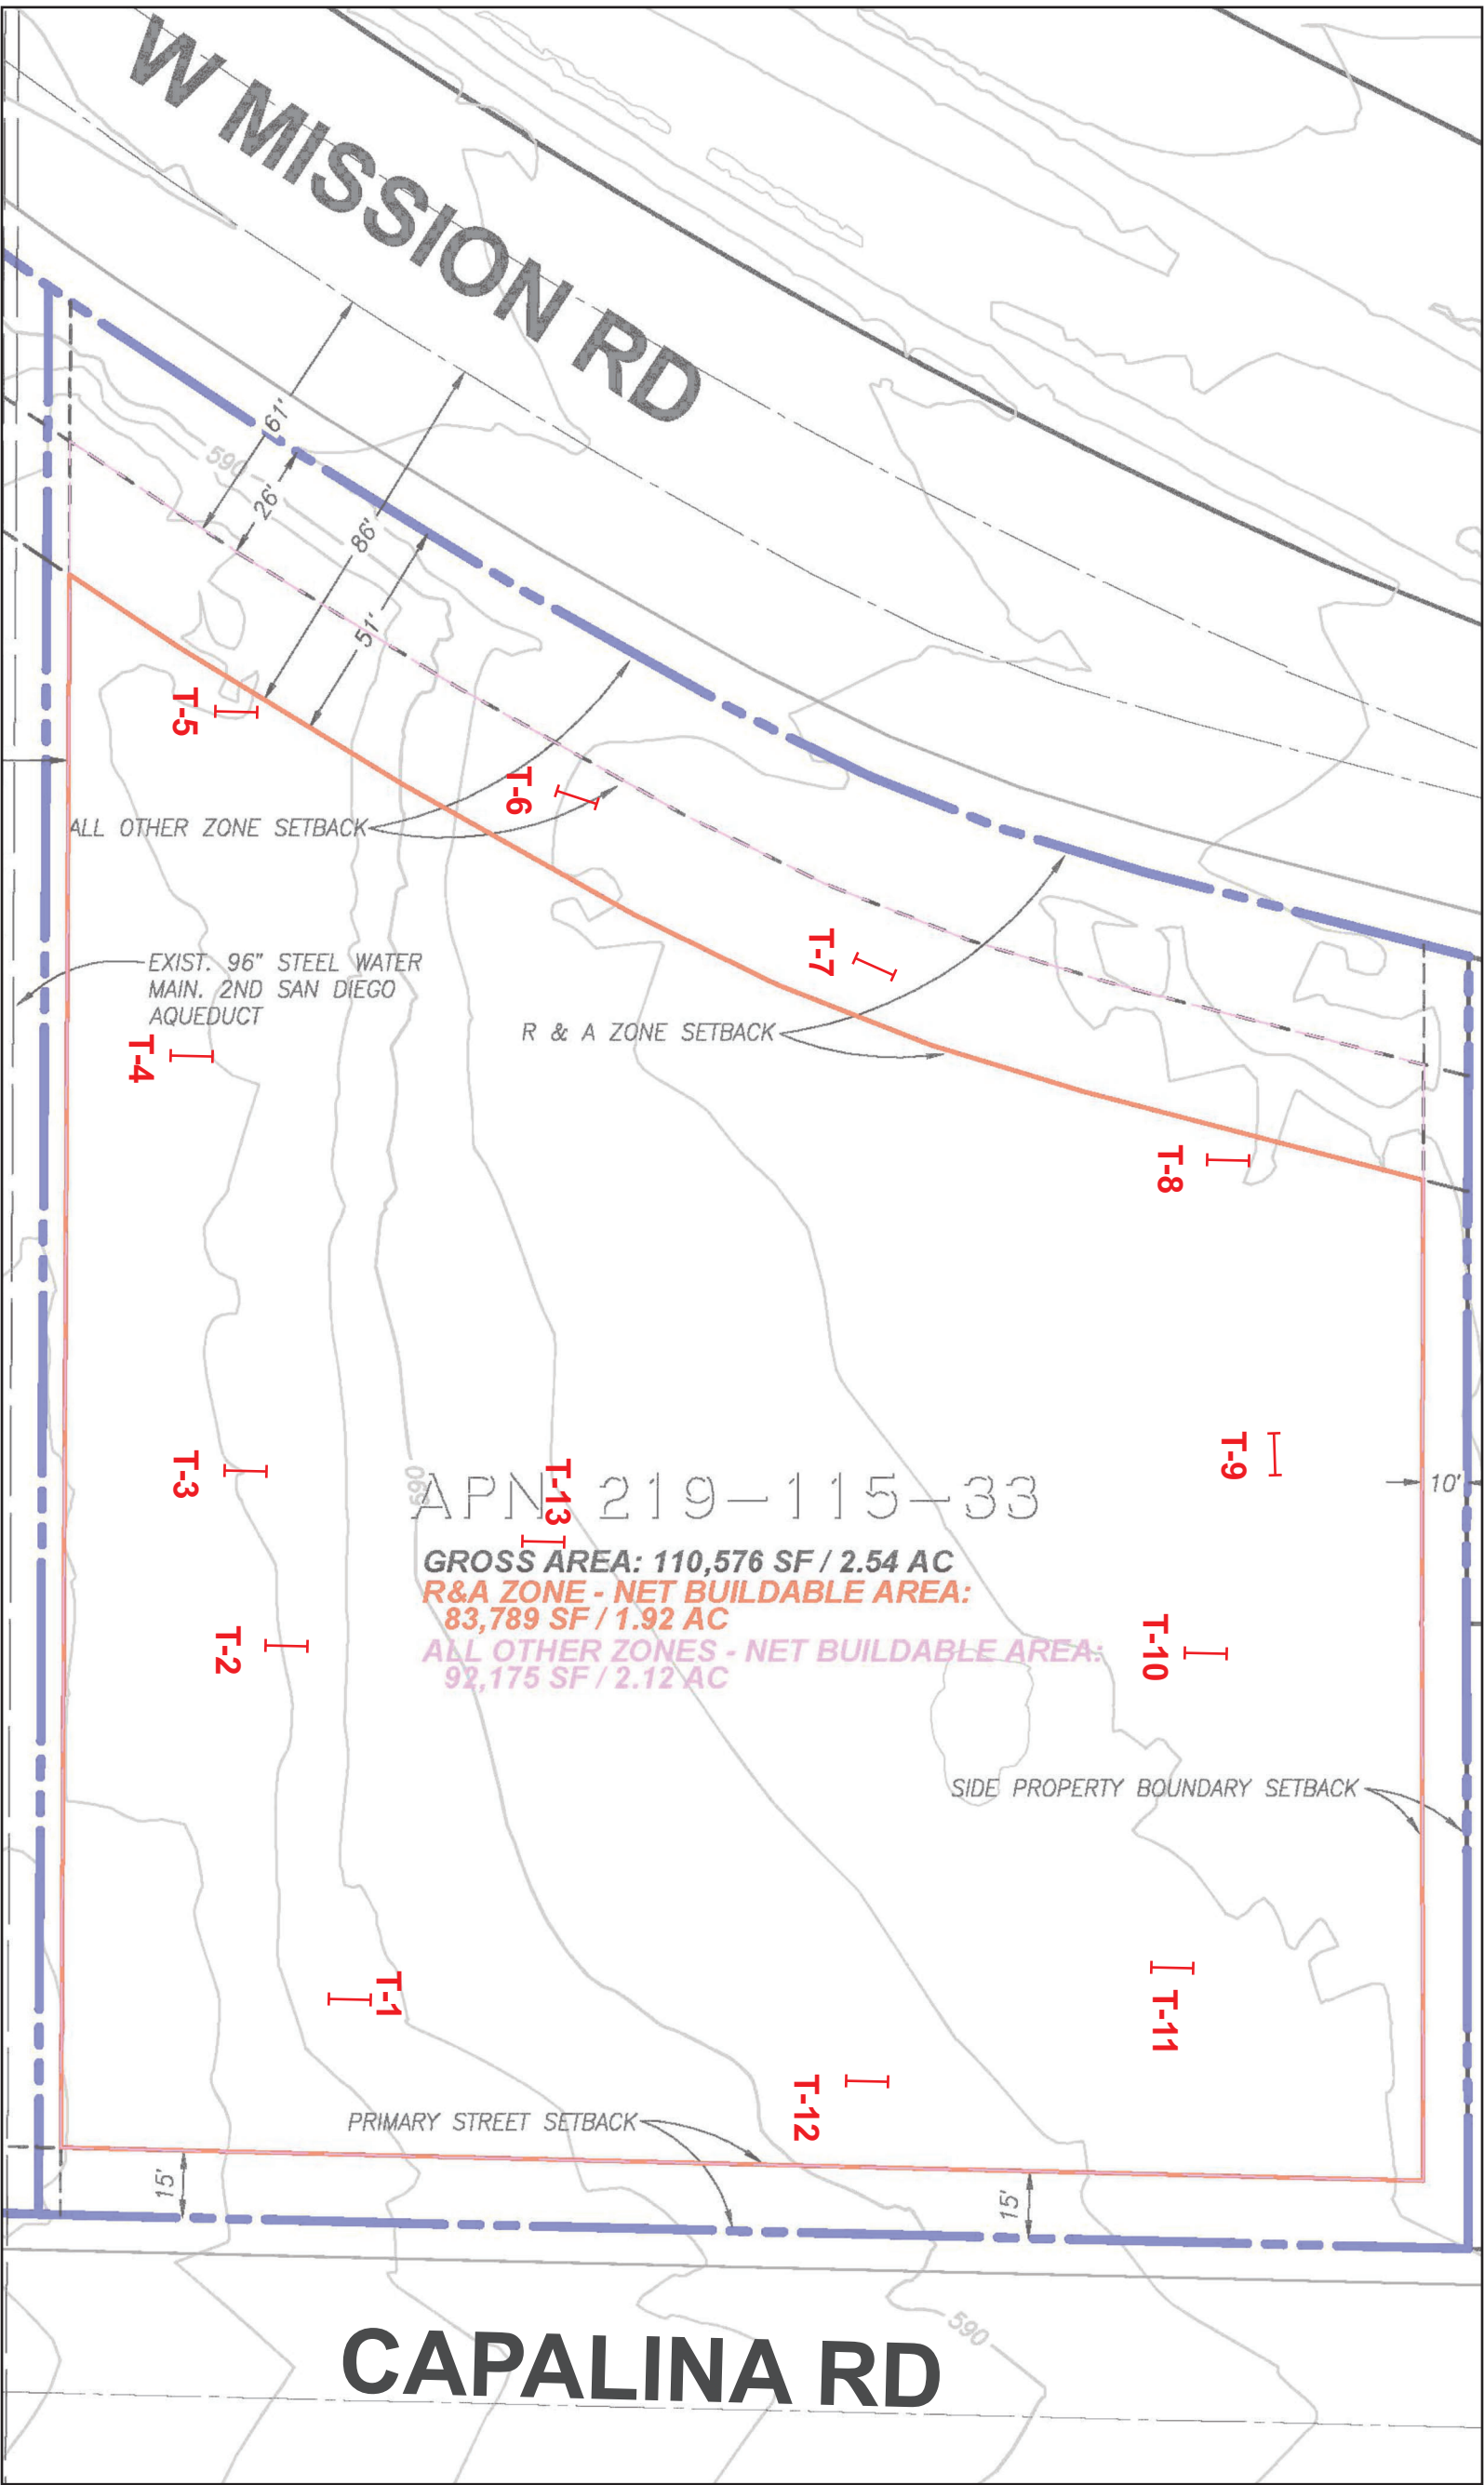
TEST PIT LOCATION PLAN
FIGURE 2

T-1 Approximate location of backhoe test pit (AGS 2022)

On March 25, 2022, AGS performed subsurface exploration at the site consisting of excavating thirteen test pits using a rubber tired backhoe to depths of up to 13.5 feet below ground surface. The test pits were logged and sampled by a representative of this firm. The locations of the exploratory test pits are presented on Figure 2, Test Pit Location Plan. Test pit logs are presented in Appendix B.

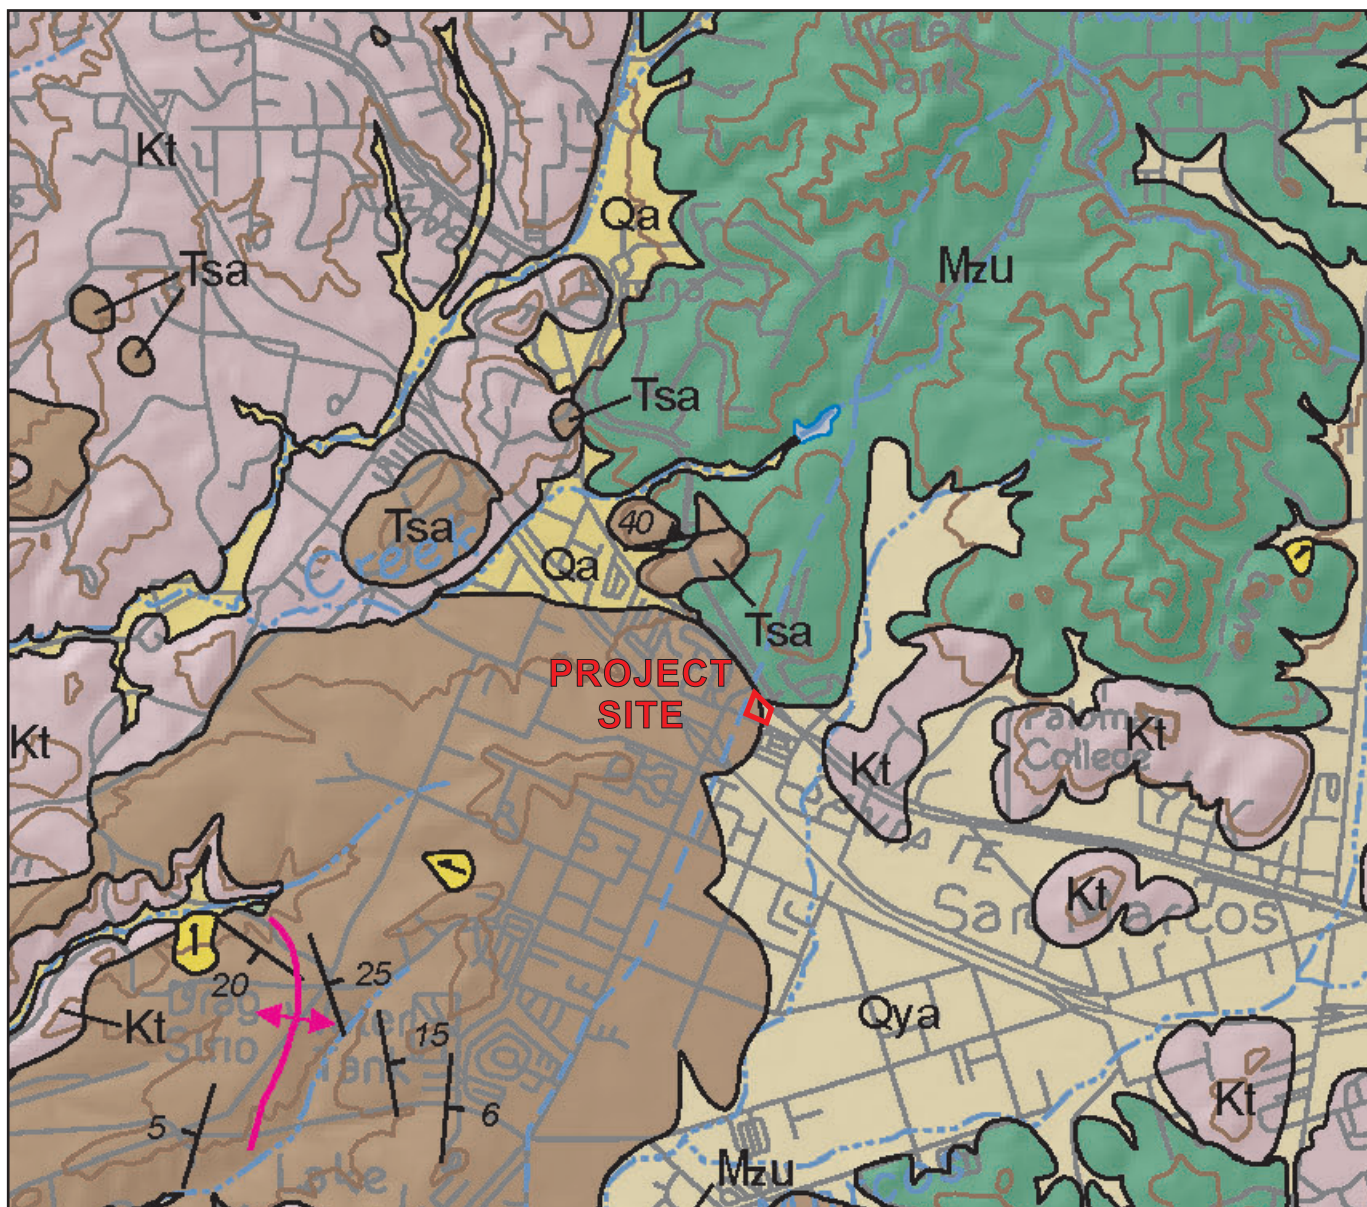
FIGURE 3

**REGIONAL GEOLOGIC MAP
CAPALINA APARTMENTS
CAPALINA ROAD
SAN MARCOS, CALIFORNIA**

The earth materials present at the site consist of surficial deposits of undocumented artificial fill and topsoil/alluvium overlying sedimentary rock assigned to the Santiago Formation. The site is geologically mapped as sitting near the boundary of the Santiago Formation and undifferentiated metasedimentary and metavolcanic rock (See Figure 3, Regional Geologic Map) although metasedimentary / metavolcanic rock was not encountered during our study. The following is a brief description of the subsurface materials encountered.

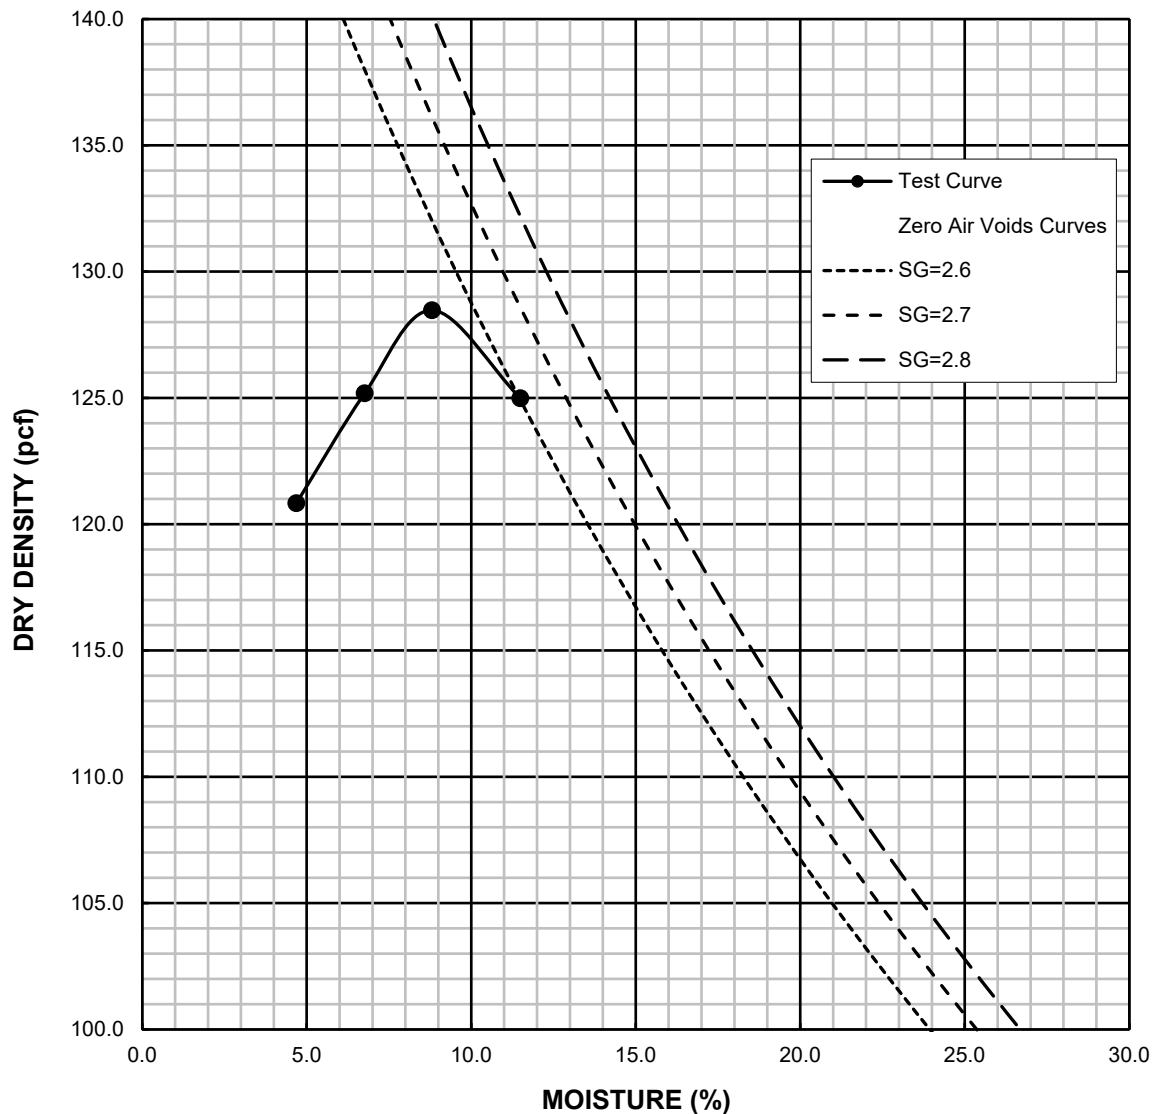
MAXIMUM DENSITY CURVE

Method:	A			Oversize Retained: 25.3 %
Point No.	1	2	3	4
Dry Density (pcf)	120.8	125.2	128.5	125.0
Moisture Content (%)	4.7	6.8	8.8	11.5

Corrected Max. Dry Density 136.3 pcf

Max. Dry Density 128.4 pcf

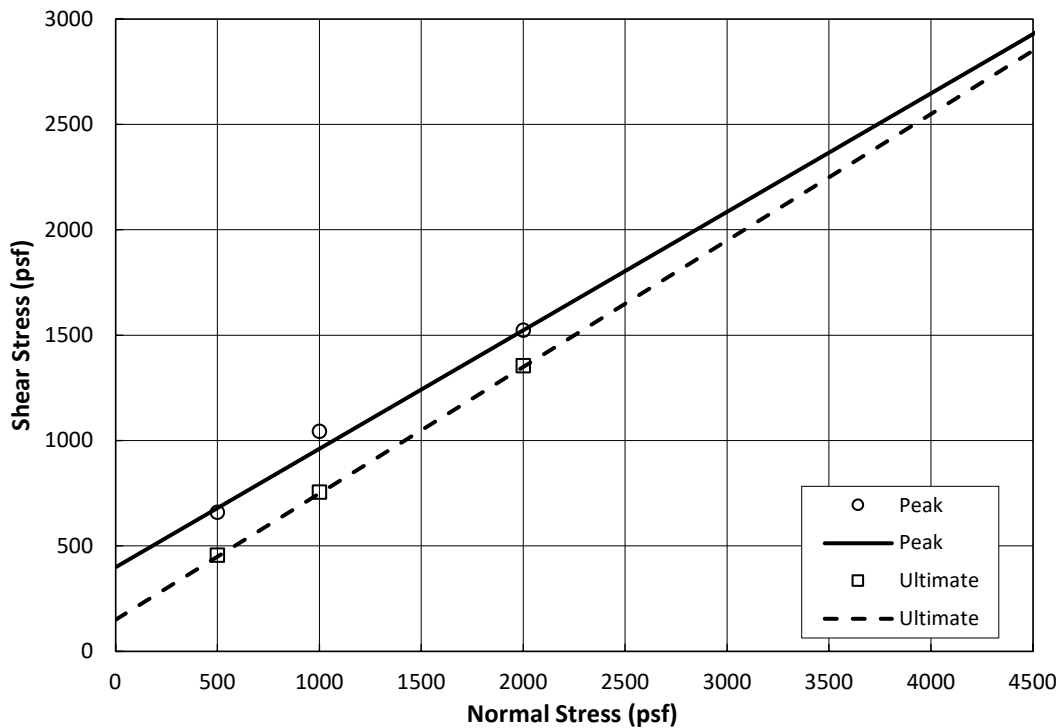
Shear Rate (ⁱⁿ/min): 0.01

Strength Parameters	Peak	Ultimate
Friction Angle, phi (deg)	29	31
Cohesion (psf)	400	150

TABLE 5.1.5 Shear Strengths Used for Design (Ultimate)			
Material	Cohesion (psf)	Friction Angle (degrees)	Moist Density (pcf)
Compacted Fill	150	31	125
